CASE STUDY

AUCKLAND AIRPORT

RUNWAY

DURAFORCE® AS410 NON-WOVEN GEOTEXTILE

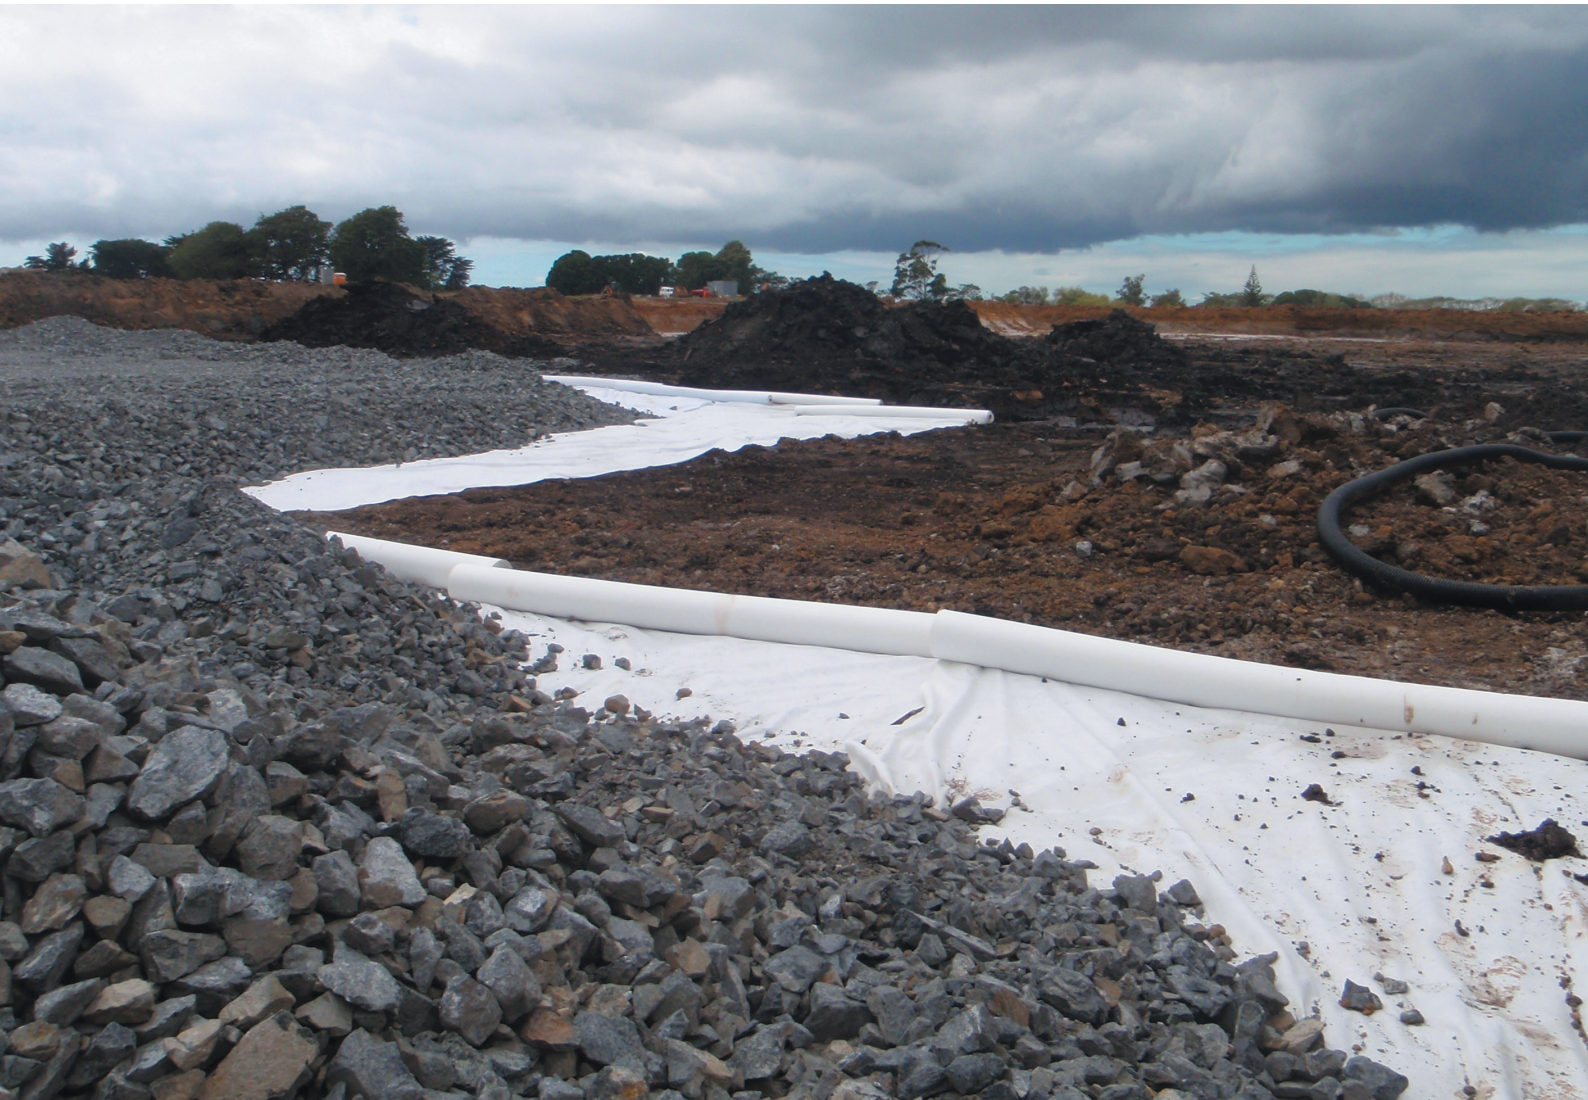
DuraForce AS410 non woven geotextile was used on this major infrastructure project at Auckland International Airport. Contractors Fulton Hogan were excavating for this high load pavement area and uncovered a peat swamp, complete with large partly rotten tree trunks. Geotech engineers from Beca called to the site judged that the swamp was too deep to be economically removed entirely and recommended that only the rotting trees be removed and a non woven geotextile complying with TNZ F7 strength class C be laid over the swamp, followed by 500mm of hard fill.

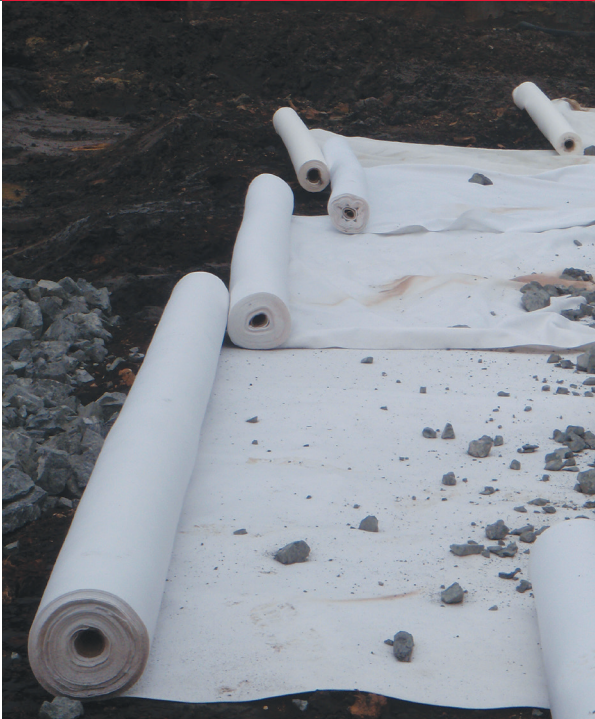
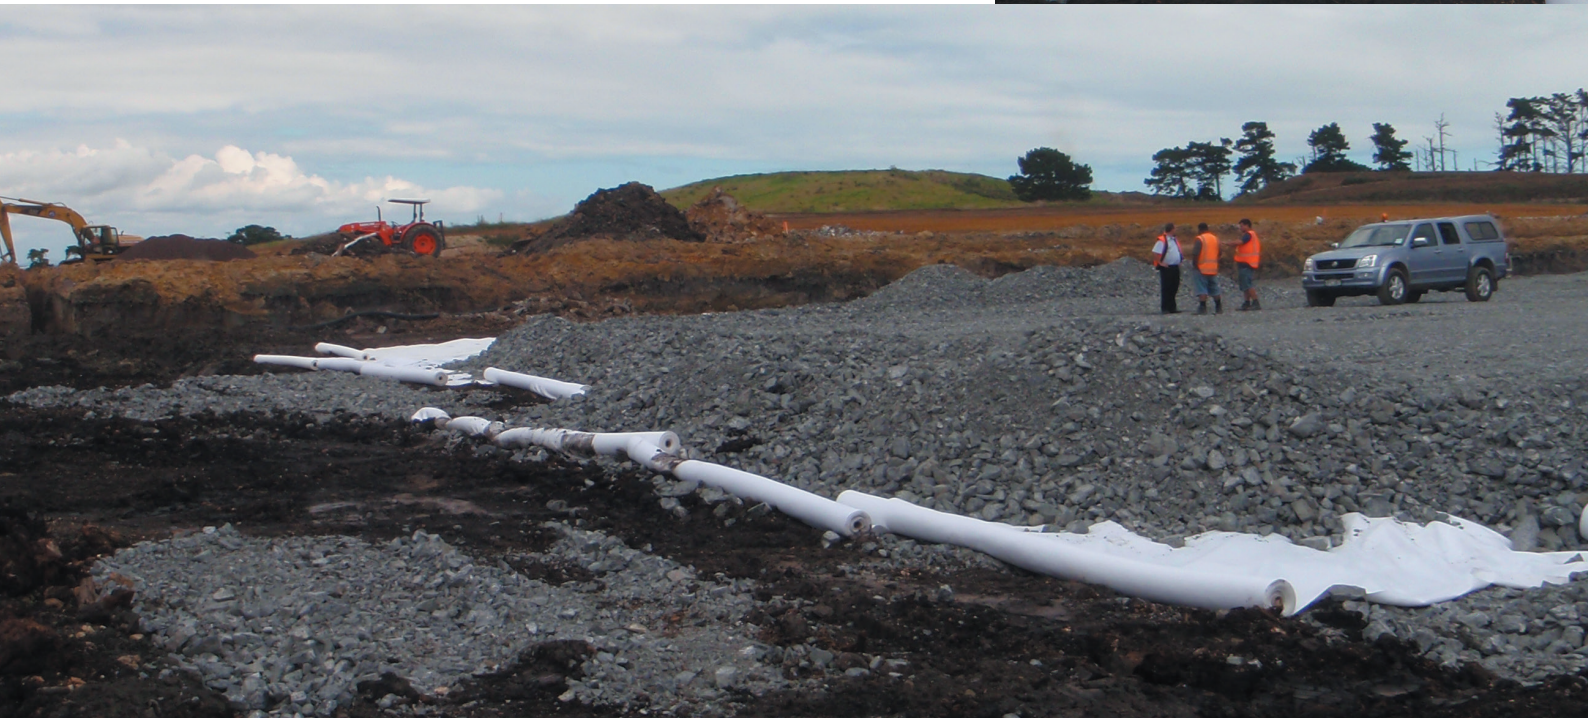
These photos show the aggregate used, being a hard angular crushed rock. This demonstrates the excellent puncture resistance and strength of DuraForce in this application where the dual functions of separation and reinforcement were required.
