Asphalt Reinforcement

Pavement Rehabilitation

Rehabilitation of the Runway 06 at Perth Airport in Australia: Effective asphalt reinforcement with HaTelit® C 40/17

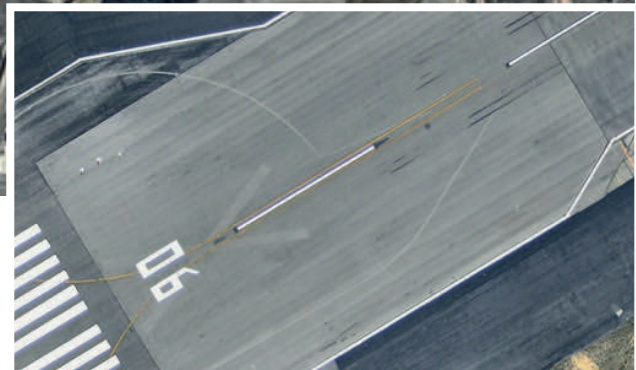
Aerial Photo of the Runway 06 Threshold in 2020

In 2020, approximately 10 years after the rehabilitation, the condition of the Runway 06 was checked during a visual inspection. The pavement was found to be in an extremely good condition, without the propagation of the existing cracks and joints, well exceeding the expectations.

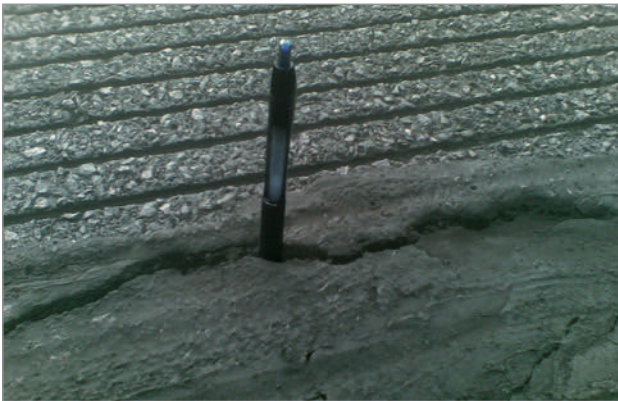
Wide crack (reflective crack) before rehabilitation works

Due to the severely cracked condition of the existing pavement, resurfacing by using just a thin asphalt overlay was not expected to provide a long-term success. To solve this problem, the propagation of existing cracks and expansion joints from old concrete slabs into the new asphalt overlay needed to be prevented.

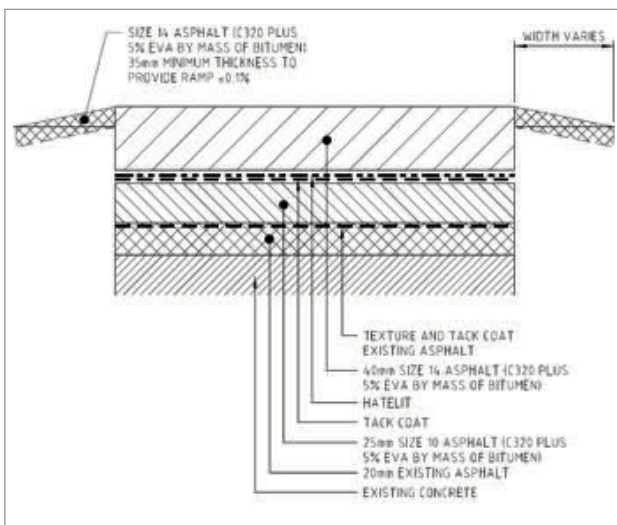
Design for the pavement rehabilitation

The rehabilitation procedure involved firstly texturing of the existing asphalt surface and construction of a 25 mm thick asphalt layer. Subsequently, the asphalt reinforcement HaTelit C 40/17 was placed in accordance with the installation guidelines, and then covered with a 40 mm asphalt wearing course.

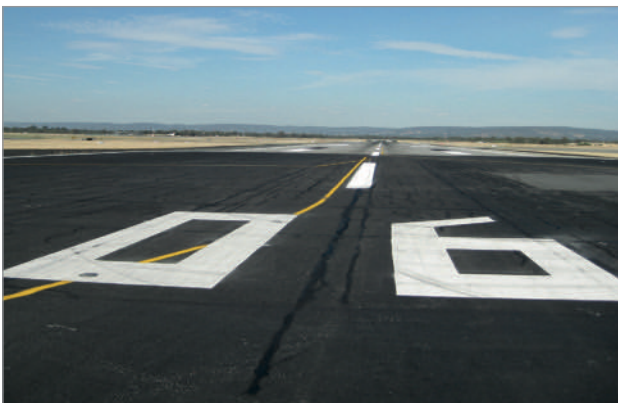
Pavement condition in 2009 prior to rehabilitation

Perth Airport is the fourth busiest airport in Australia in terms of passenger traffic, operating 24 hours a day, seven days a week. In 2009, after repeated maintenance works over many years, an effective rehabilitation of the extensively cracked Runway 06 Threshold was required to restore its serviceability. The existing pavement consisted of 300 mm concrete slabs constructed in 1960, which were later overlaid with 20 mm asphalt surfacing.

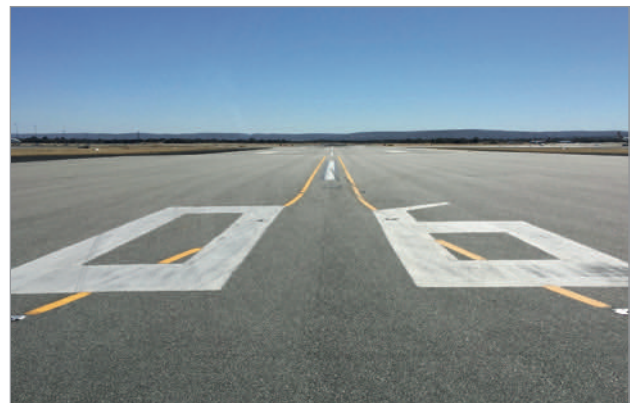
Situation approx. 10 years after rehabilitation with HaTelit C 40/17
