CASE STUDY

COLVILLE COAST STORM

DAMAGE REPAIRS

DURAGREEN™ SYSTEM

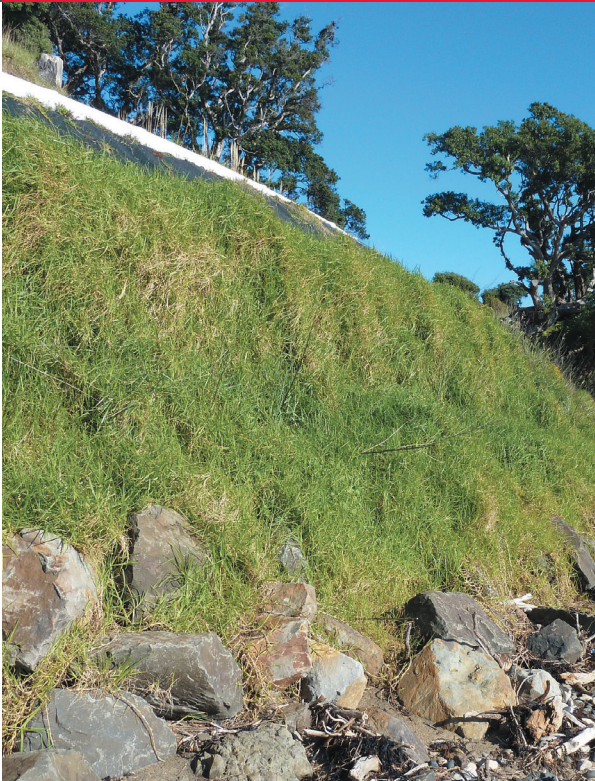
This wall uses the DuraGreen System. Also available is the DuraMesh System with wire mesh facing.

The completed project provides an environmentally friendly mechanically reinforced solution for this common problem.
